## Description of storm damage

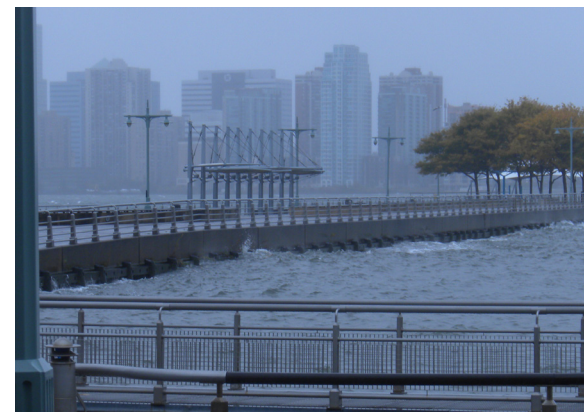
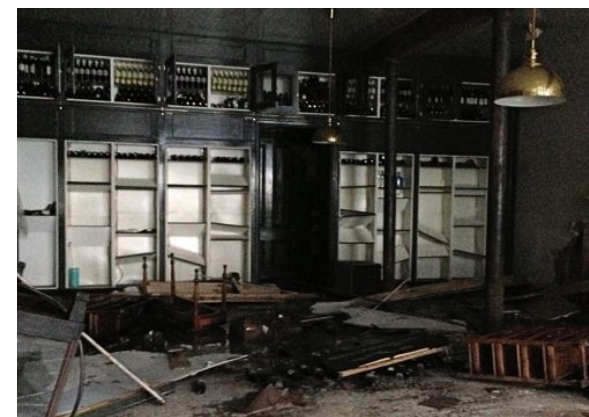
Superstorm Sandy rattled the west side, seen at top at Christopher Street Pier. Damage was extensive to retail businesses throughout the Focus Area, including in the South Street Seaport Historic District (bottom). Sources: courtesy of Robert Woodworth (top); courtesy of Pasanella & Son Vintners (bottom).

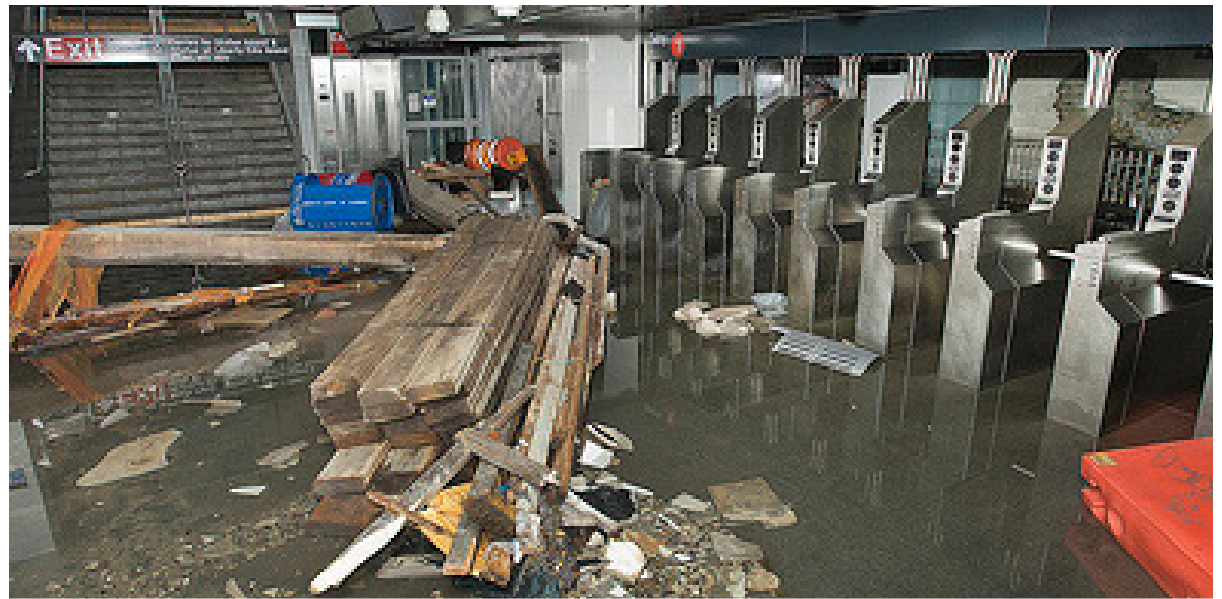
Subway stations suffered serious damage from Sandy, including South Ferry station. A blackout engulfed Lower Manhattan (below). Sources: Flickr user MTAPhotos (Metropolitan Transportation Authority/Patrick Cashin) (top); Flickr user Dan Nguyen (bottom). Both licensed under Creative Commons.

salt water damaged important electrical and communications equipment, including signal relays that prevent train collisions. Among the most severely damaged subway assets was the South Ferry 1 train Station—a loss that will require multiple years to repair. Other damaged assets include the World Trade Center PATH station and the Montague Tunnel, which connects the R train to Brooklyn. The Holland Tunnel to New Jersey, the Battery Park Underpass of the Franklin D. Roosevelt (FDR) Drive, and the Hugh L. Carey Tunnel to Brooklyn were fully flooded, the latter taking over three weeks to fully reopen.
